Emergency project saves water intake and supply

Heavy rains compromise the intake

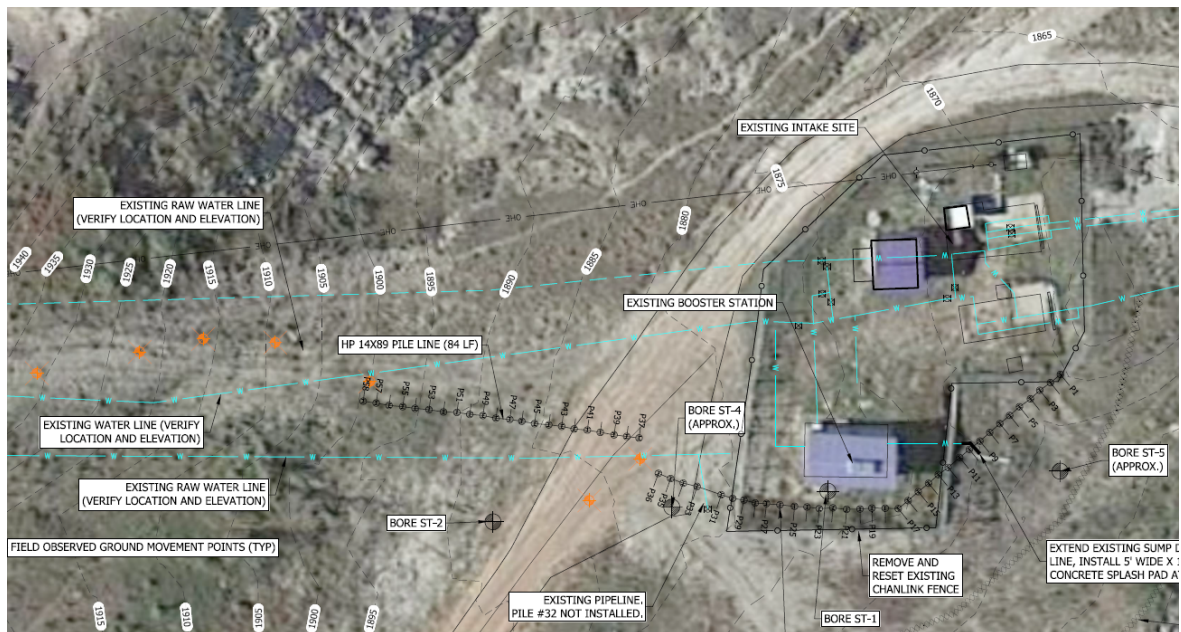
Figure 1. From Slide Area Pile Line Site Plan

Even prior to the slide, that intake site was already a cause for concern. In fact, in 2017, Bartlett & West and Braun Intertec worked together to protect key infrastructure and secure the intake after analysis showed that the hillside was compromised. At that time, movement of the landslide mass produced a pattern of ground cracks that suggested the intake's booster station, along with the water lines that extend south from the booster station toward Mandaree, could be at risk. Piles were drilled into the bank to help reinforce it, shown in Figure 1. Fast-forward to late 2019. Landenberger points out that the bank erosion all occurred directly below the line of the previously buried piles, with the pump station and bank located above and safely protected.

Landenberger said, “Drilling into an already unstable bank is not ideal. We were concerned that doing so might further contribute to the destabilization. However, those piles definitely saved the intake from being a complete loss when the slide occurred. They prevented a catastrophic failure.”
