## Data and evidence show the way

*Authors: Michael F. Lorenzo, P.E., engineer at Bartlett & West and Michelle Neiswender, P.E., project manager at City of Topeka Utilities, Topeka, KS*

The Citywide Sewer Cleaning and Closed-Circuit Television (CCTV) Inspection Program began at the end of 2018. The goals of the program are to ensure that the operation and maintenance efforts continue to meet permit requirements and desired levels of service. This program was designed and implemented to enable the city to operate proactively and more strategically manage their collection system.

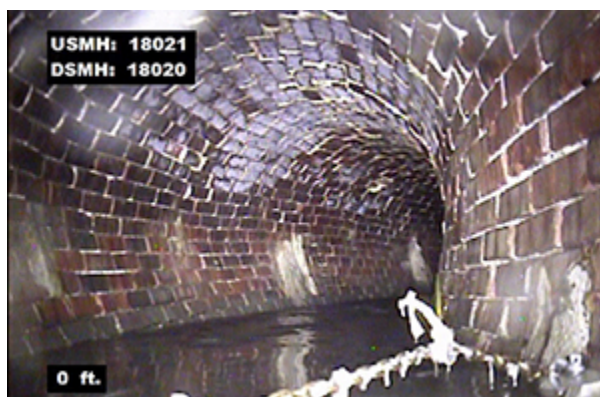
Brick storm sewer pipe

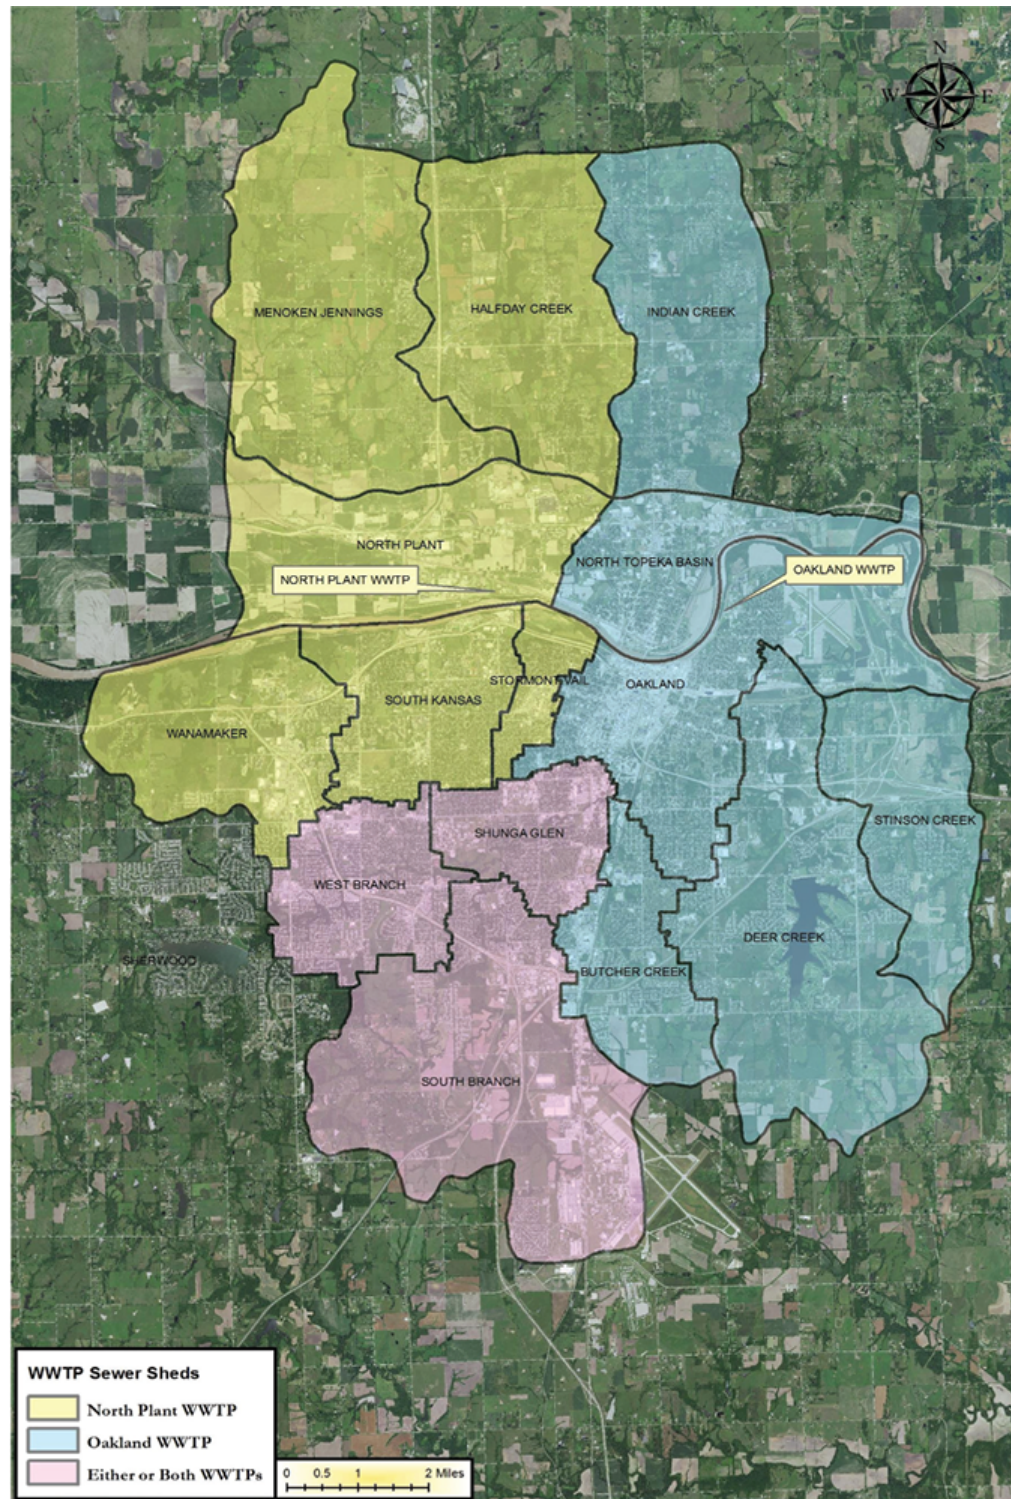
Figure 1. City of Topeka Sewer Sheds

The overall collection system consists of 15 wastewater basins as shown in Figure 1 (p. 35). The total area of all basins is approximately 383 km<sup>2</sup> (148 mi<sup>2</sup>). The two CSS basins, North Topeka, and Oakland, have an area of 46.6 km<sup>2</sup> (18 mi<sup>2</sup>). Two WRRFs provide treatment of flows collected by the system. The 1.05 m<sup>3</sup>/s (24 million gal/d) peak flow North Plant Wastewater Treatment Plant serves basins in the west and northwest while the 4.38 m<sup>3</sup>/s (100 million gal/d) peak flow Oakland Wastewater Treatment Plant serves basins in the south, central, and east.

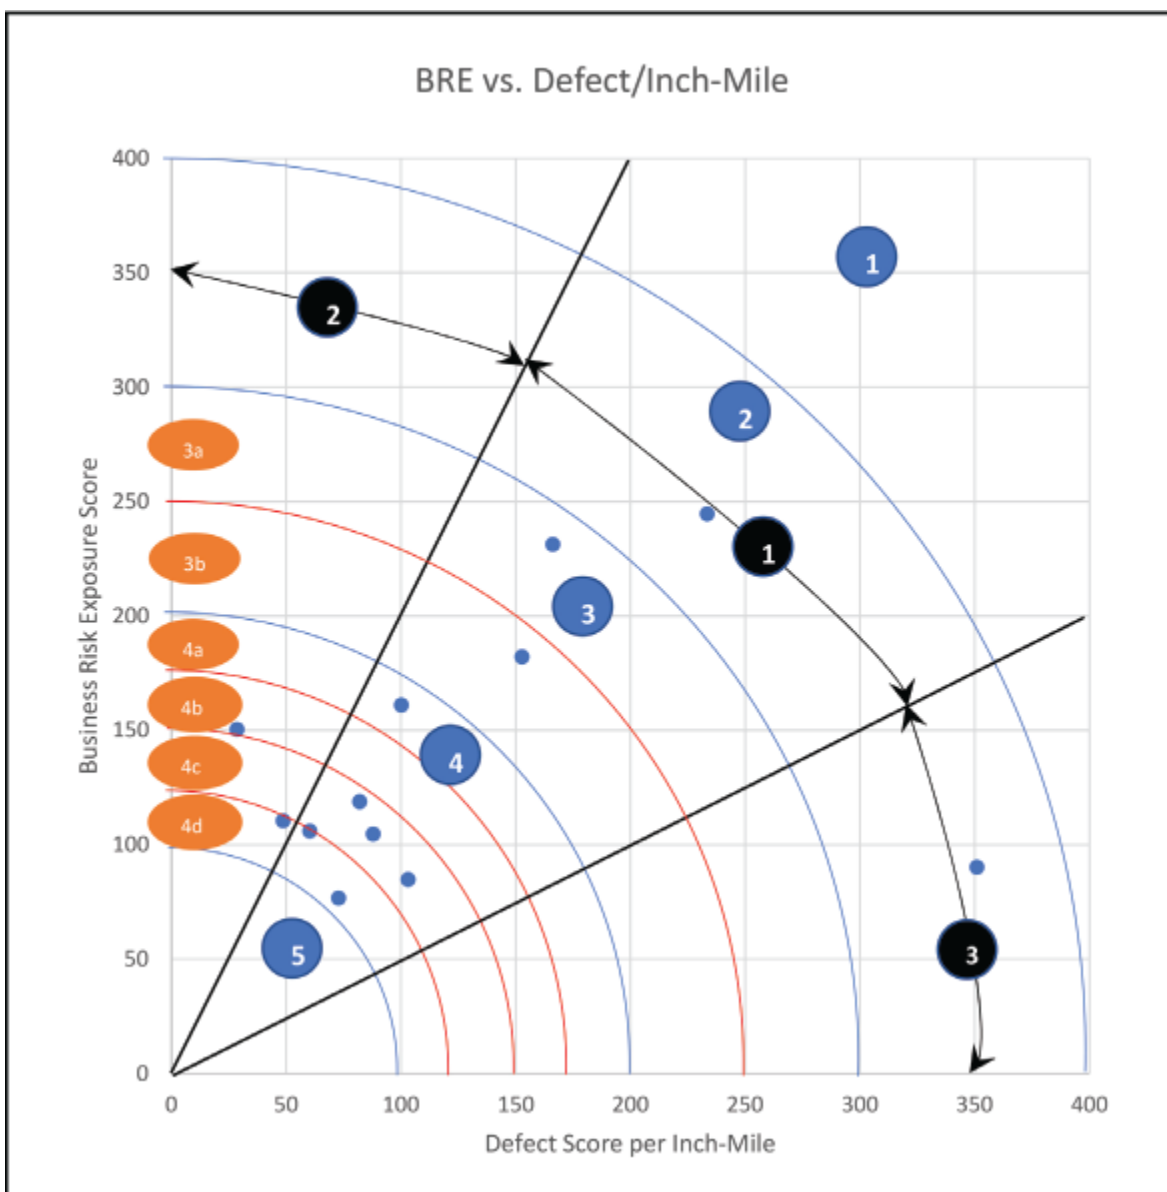
Table 3 (p. 38) summarizes the BREs, overall defect scores, and priority rankings of the 11 areas. The consolidated BRE and overall quarter section defect ratings for each quarter section are plotted on a graph to identify quarter sections with the highest overall risk in terms of consequences of failure (BRE) and likelihood of failure (overall defect rating). Figure 3 (below) presents BRE versus overall defect rating for 11 quarter section areas and the West Edge area project.

Figure 3 is divided into major risk zones, major risk zone sectors, and major risk subzones. The lower the number and number-letter combination, the higher the risk is considered. Therefore,

major risk zone 1 has the highest criticality; risk sub-zone 4a is more critical than risk sub-zone 4b; major risk zone 5 is the least critical. The risk zones were developed to enable a more balanced consideration of areas with high overall defect ratings and low BRE scores against areas with high BREs and lower overall defect ratings.
