INSIGHT

Data and evidence show the way

Authors: Michael F. Lorenzo, P.E., engineer at Bartlett & West and Michelle Neiswender, P.E., project manager at City of Topeka Utilities, Topeka, KS

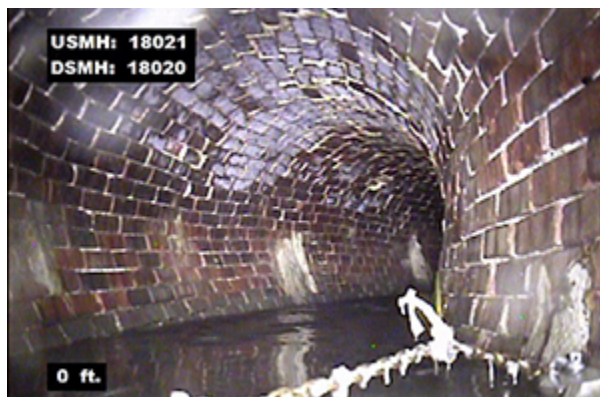
Brick storm sewer pipe

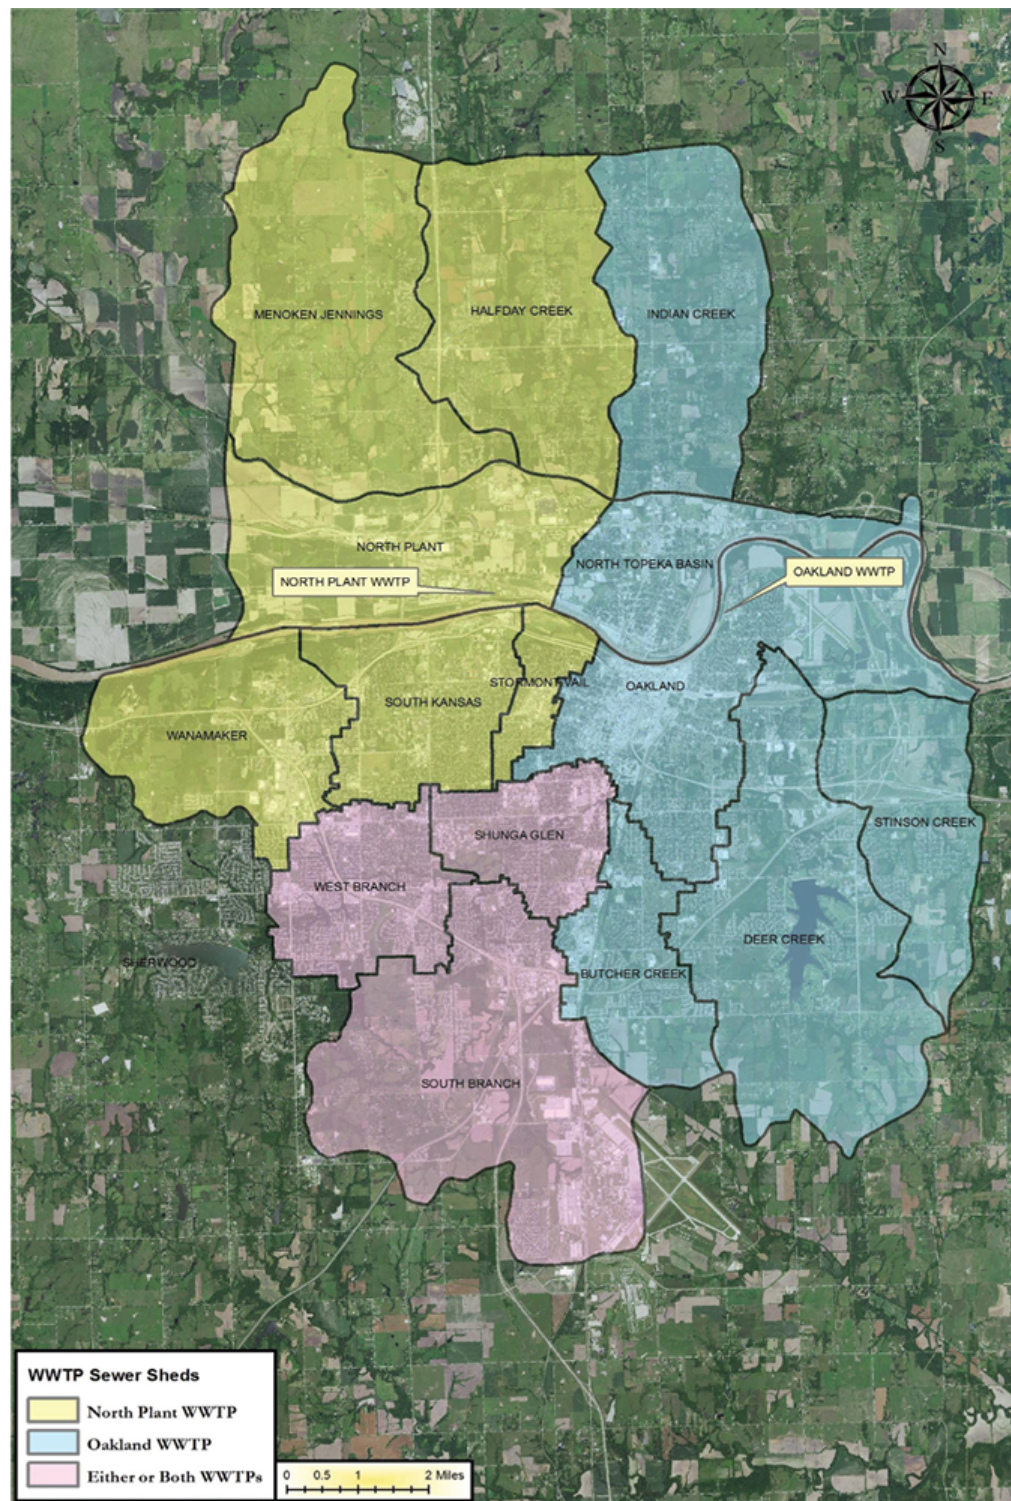
Figure 1. City of Topeka Sewer Sheds

The overall collection system consists of 15 wastewater basins as shown in Figure 1 (p. 35). The total area of all basins is approximately 383 km² (148 mi²). The two CSS basins, North Topeka, and Oakland, have an area of 46.6 km² (18 mi²). Two WRRFs provide treatment of flows collected by the system. The 1.05 m³/s (24 million gal/d) peak flow North Plant Wastewater Treatment Plant serves basins in the west and northwest while the 4.38 m³/s (100 million gal/d) peak flow Oakland Wastewater Treatment Plant serves basins in the south, central, and east.

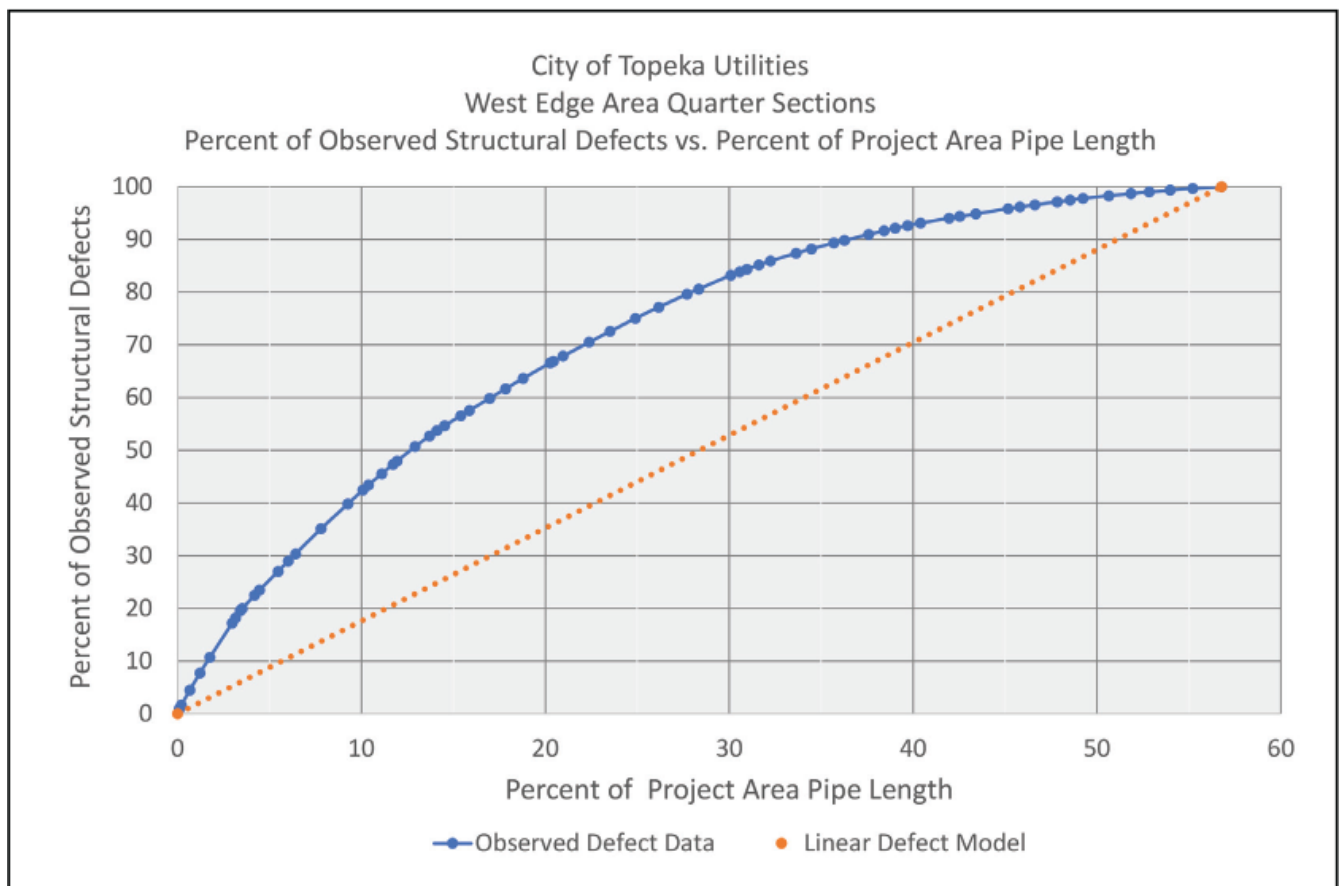
The use of a cost-effectiveness of 1.00 also was assessed through a knee-of-the-curve analysis in which percent of observed structural defects for each area was plotted against percent of project area pipe length. Figure 2 (p. 37) shows an example of this plot for the West Edge project area.

Figure 2 shows a comparison between the actual observed conditions, and the improvements that might be expected if structural defects were evenly distributed throughout the area pipes. The inflection point of the observed defect data is found to occur at approximately 26% of the project area pipe length and is associated with elimination of 46% of structural defects.

This correlates to a pipe in the West Edge area with a cost-effectiveness factor of about 2.95. Similar results are obtained for the other project areas. Therefore, the cost-effectiveness factor of 1.00 is conservative in that it is generally somewhat past the knee-of-the-curve. (The development of manhole improvement recommendations was performed similarly to pipes although a cost-effectiveness factor was not used.)

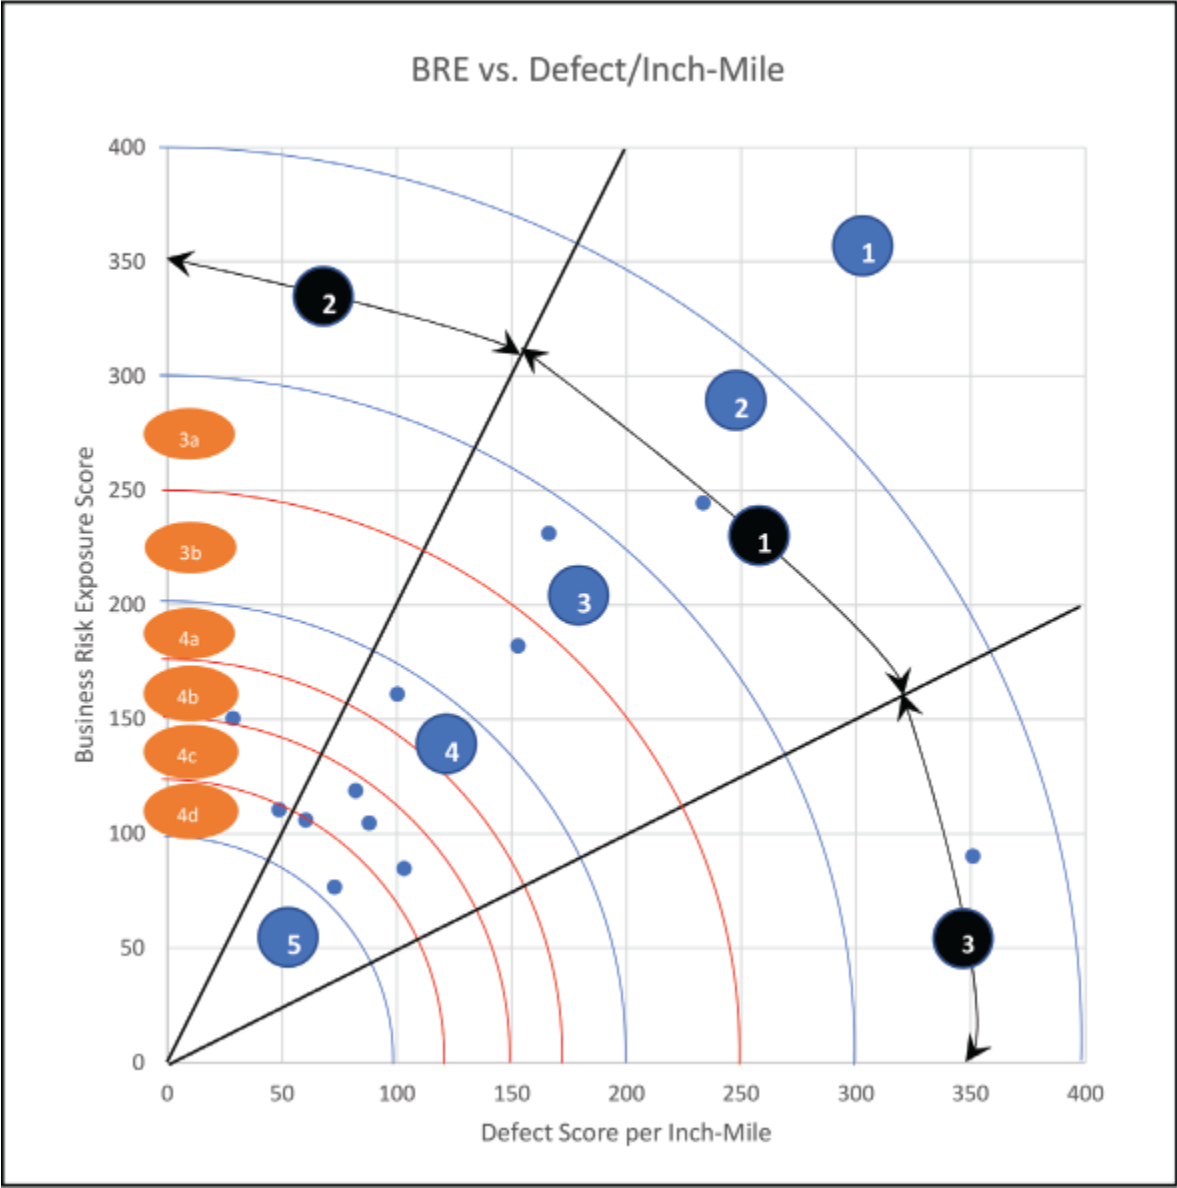
Table 3 (p. 38) summarizes the BREs, overall defect scores, and priority rankings of the 11 areas. The consolidated BRE and overall quarter section defect ratings for each quarter section are plotted on a graph to identify quarter sections with the highest overall risk in terms of consequences of failure (BRE) and likelihood of failure (overall defect rating). Figure 3 (below) presents BRE versus overall defect rating for 11 quarter section areas and the West Edge area project.

Figure 3 is divided into major risk zones, major risk zone sectors, and major risk subzones. The lower the number and number-letter combination, the higher the risk is considered. Therefore,

major risk zone 1 has the highest criticality; risk sub-zone 4a is more critical than risk sub-zone 4b; major risk zone 5 is the least critical. The risk zones were developed to enable a more balanced consideration of areas with high overall defect ratings and low BRE scores against areas with high BREs and lower overall defect ratings.
