## Emergency project saves water intake and supply

When the bank of Lake Sakakawea began to slide after heavy rains, there was limited time to respond. Those slopes hold the access road and pipelines for Fort Berthold Rural Water's intake, which serves the Mandaree water treatment plant and supplies raw water to the Bakken oil field.

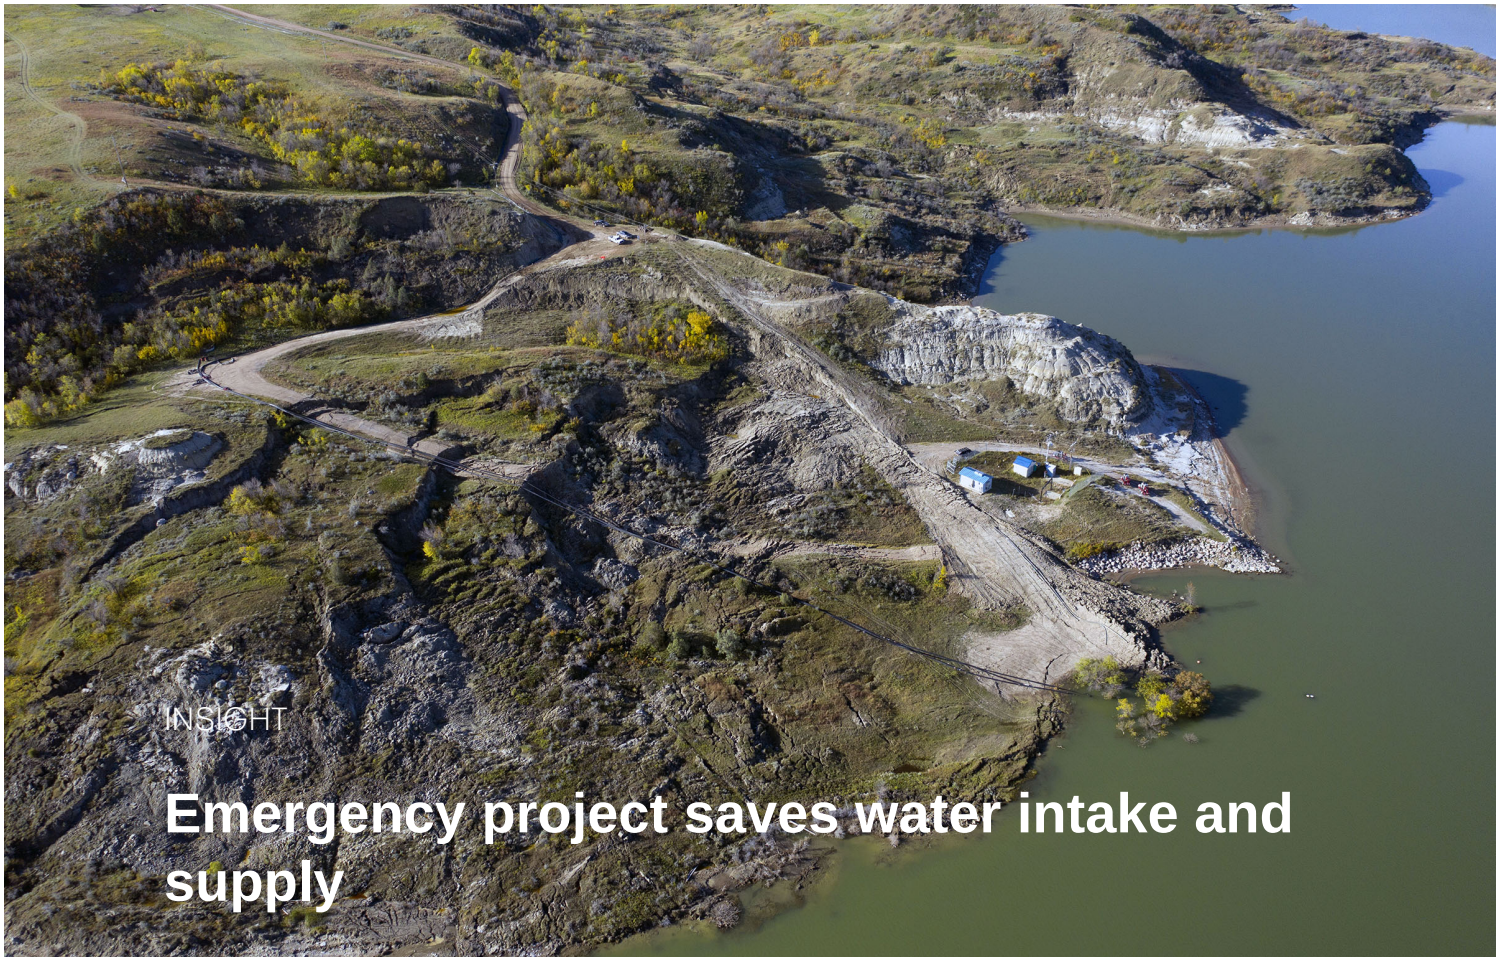
After a weekend of heavy rainfall in late September 2019, the bank of the intake began to slide. The landslide measured approximately 1,000 feet in width and length, covering a vertical elevation range of about 250 feet. As James Landenberger, a professional engineer at Bartlett & West, said, "I've been involved in civil engineering for 20 years and I've never seen a slide like this." Landenberger said the bank looked like lava flow as it slid away.

The damage caused by the slide was massive and called for emergency repairs. A team from Bartlett & West, Braun Intertec and various contractors sprang into action. They had to work quickly because if another shift occurred there was potential to lose all water supply, the entire site and the intake.

Ultimately, in just a few months after the slide, all repairs were completed. Two new raw water pipelines were installed at the site, with the other line abandoned. Those new lines were horizontally, directionally drilled rather than trenched to limit further effect on the already compromised site. The access road and intake were also repaired.

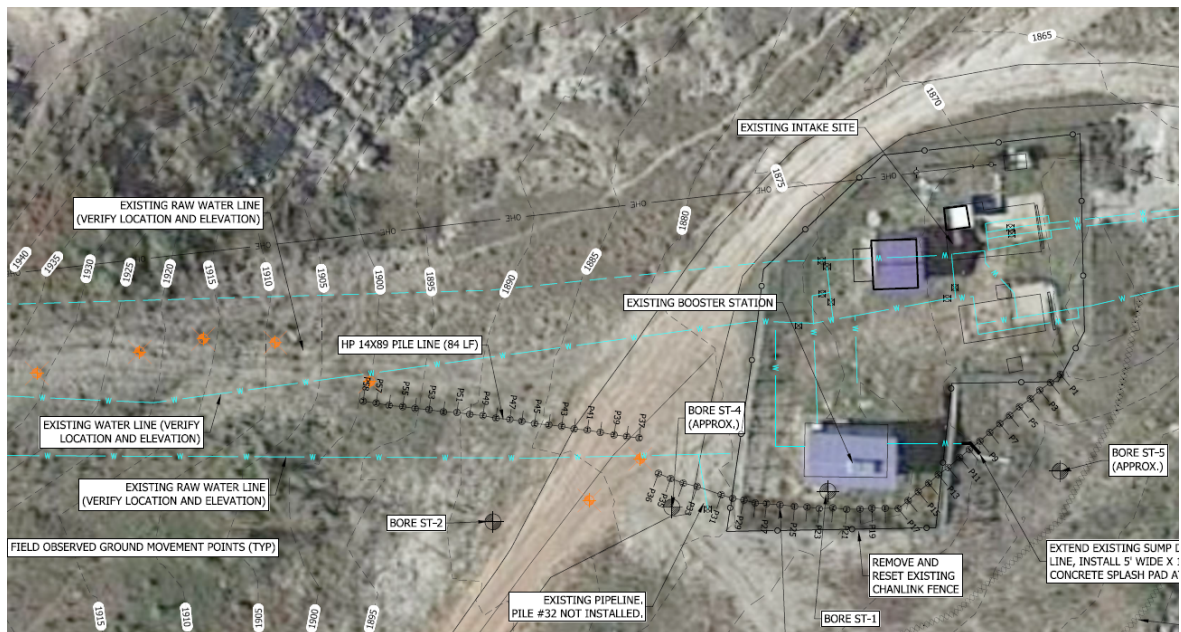
Figure 1. From Slide Area Pile Line Site Plan

Even prior to the slide, that intake site was already a cause for concern. In fact, in 2017, Bartlett & West and Braun Intertec worked together to protect key infrastructure and secure the intake after analysis showed that the hillside was compromised. At that time, movement of the landslide mass produced a pattern of ground cracks that suggested the intake's booster station, along with the water lines that extend south from the booster station toward Mandaree, could be at risk. Piles were drilled into the bank to help reinforce it, shown in Figure 1. Fast-forward to late 2019. Landenberger points out that the bank erosion all occurred directly below the line of the previously buried piles, with the pump station and bank located above and safely protected.

Landenberger said, "Drilling into an already unstable bank is not ideal. We were concerned that doing so might further contribute to the destabilization. However, those piles definitely saved the intake from being a complete loss when the slide occurred. They prevented a catastrophic failure."
